INDEPENDENT ORBITER ASSESSMENT

ANALYSIS OF THE CREW EQUIPMENT SUBSYSTEM

MCDONNELL DOUGLAS ASTRONAUTICS COMPANY
HOUSTON DIVISION

WORKING PAPER NO. 1.0-WP-VA87001-01

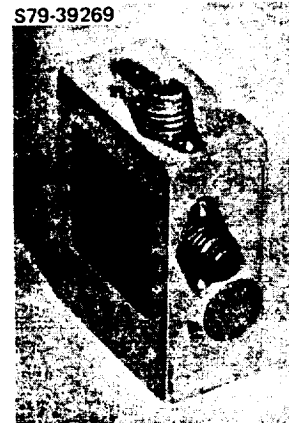
Figure 5: Operational Bioinstrumentation System

The Operational Bioinstrumentation System (OBS) provides an amplified electrocardiogram analog signal from crewmembers aboard the Orbiter to the Orbiter avionics multiplexer/demultiplexer where it is converted from analog to digital data. It is then transmitted to the ground in real time or stored on tape for dump or postflight return. The major components of the OBS are a biomed belt with signal conditioner, electrode harness, cables and electrode donning kit as shown in Figure 5.

ELECTRODE DONNING KIT

ELECTRODE HARNESS

SIGNAL CONDITIONER
